## Coal Mine Fatal Accident 2005-03

Operator:	Coal River Mining, L.L.C.
Mine:	Tiny Creek No. 2 Mine
Accident Date:	March 31, 2005
Classification:	Roof Fall
Location:	District 4, Lincoln County, West Virginia
Mine Type:	Underground

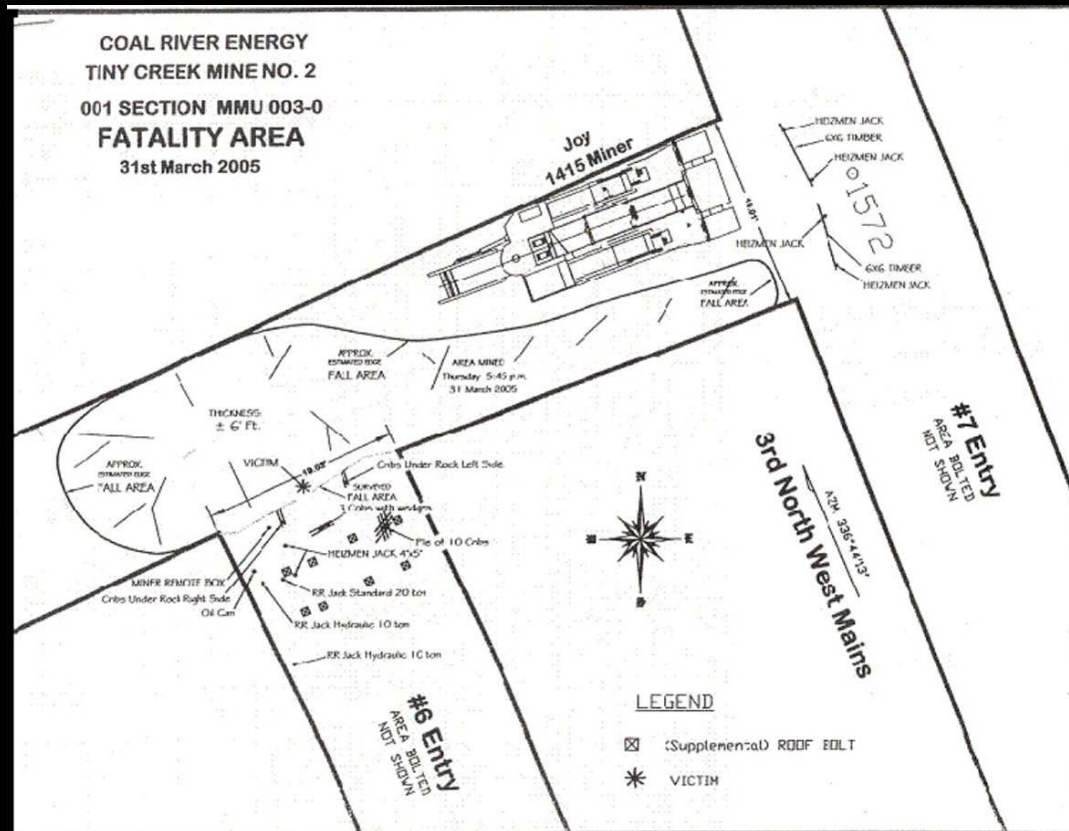
A 49 year-old cont. mining machine operator, with 28 yrs of mining experience, started mining in the crosscut between the No.'s 5 and 6 entries and continued mining to the no. 7 entry intersection, a cut distance of approx. 68 feet. Upon completion of the cut, the victim was positioned between the 1<sup>st</sup> and 2<sup>nd</sup> row of permanent roof support in the no. 6 entry. The unsupported roof in the intersection of the no. 6 right crosscut fell, overriding the 1<sup>st</sup> row of roof bolts, catching the victim near the edge of the fall and causing fatal injuries.

Causal Factor: The approved roof control plan was not being complied with on the 3 Northwest Mains section. An extended cut was mined from the number 5 right crosscut at survey station number 1574 through the number 6 entry and continued through the number 6 right crosscut to the number 7 entry, a distance of approximately sixty-eight (68) feet. The continuous mining machine operator was positioned inby the 2nd full row of roof bolts while mining a deep cut in the number 6 right crosscut. The depth of the cut from the number 5 right crosscut to the number 7 entry was not reduced where loose, broken roof was present and not cut down. Reflective devices were not installed on the second full row of roof bolts outby the face. During an accident investigation, reflectors were observed on the 5th row of bolts outby the faces of the number 5 right crosscut and the No. 6 entry.

Causal Factor: The number 6 right crosscut was started from an area that was not supported, in violation of the approved roof control plan. The crosscut was mined from the adjacent number 5 right crosscut and the number 6 entry face was not fully roof bolted.

The accident occurred because the approved roof control plan was not being followed when an extended cut was mined from the number 5 right crosscut, across the number 6 entry, through the number 6 right crosscut and into the number 7 entry. The victim was positioned in violation of the approved roof control plan between the last and next-to-last row of permanent roof support.

Corrective Action: All underground miners received extensive roof control re-training on April 14, 2005. The approved roof control plan was revised to require the section foreman to authorize any cuts that exceed 20 ft.

Corrective Action: All underground miners received extensive roof control re-training on April 14, 2005.
